### **Survey Found Raw Water Intake Valve Operational Deficiency**

In conducting a survey, of a 1995 30' production express fisherman (built in USA), powered by twin 6 cylinder diesel engines installed new in 2009, a raw water intake valve with a restricted operation situation was encountered.

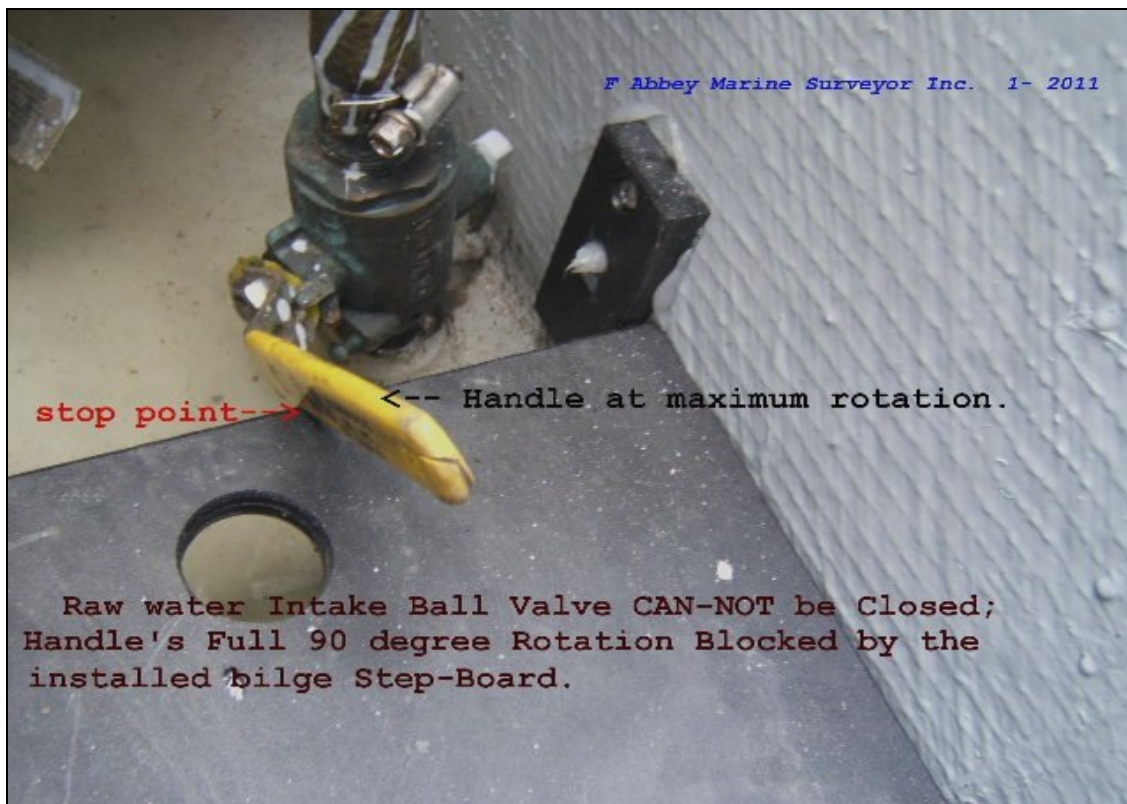
The photograph shows how full operation to close the Raw Water Intake Valve is blocked by the recently installed “bilge step board”: The step board needs a cut-out so that the valve handle can be rotated 90° and be closed. Additional issues are: A) single clamped hose (the barb was too short for double clamping). B) bronze valve & through-hull are not bonded. C) the installed valve is in-line type and not the more preferred type flanged type sea valve.
