Frank Abbey Marine Surveyor & Consultant Inc.

Survey Found Gen-Set Engine Exhaust System Deficiency

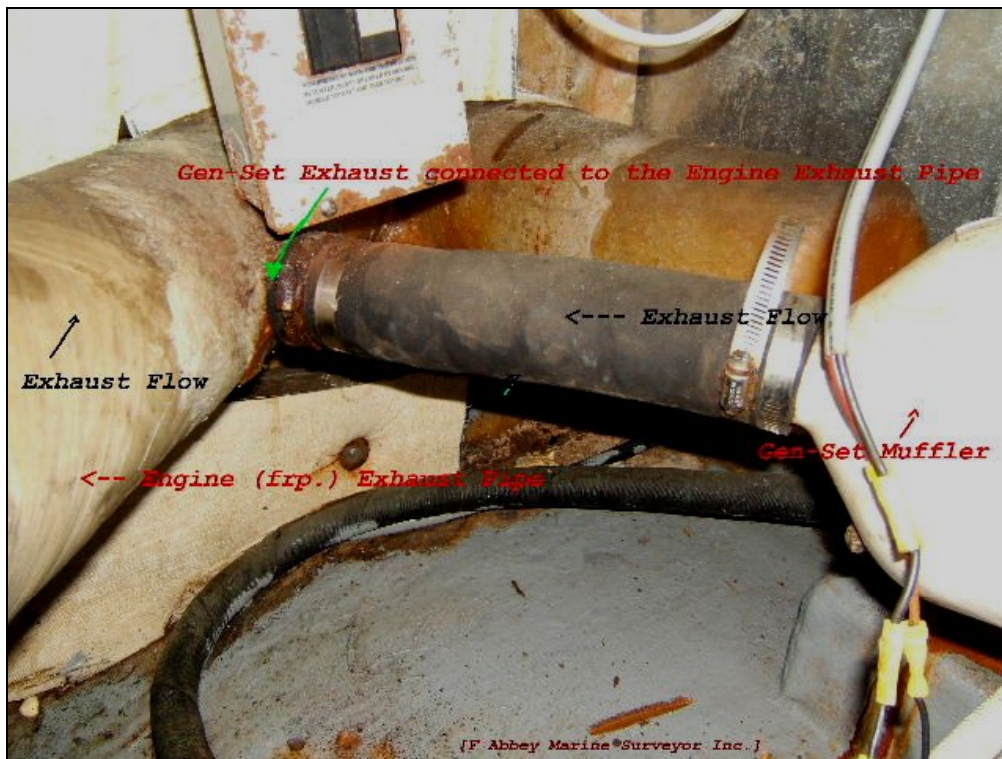
In conducting a survey, of a 1988 35' single diesel engine powered downeast fisherman equipped with an auxiliary gen-set a installed post original construction; the gen-set engine's exhaust was found to have been improperly rigged.

The photograph shows that the gen-set engine's exhaust outlet has been connected via frp. pipe (somehow) attached into the propulsion engine's frp. exhaust pipe. This situation does not comply with the provisions of **A.B.Y.C Standard P-1.5.7**. "A separate exhaust system and terminus shall be provided for each engine and generator installation; and **P-1.5.8**. Exhaust system piping and components shall be supported to minimize the risk of failure from vibration, shock, expansion, and contraction." Additional issues are: A) rusted clamp. B) worn hose. C) metal box (w/ AC breakers) chafing against the frp. exhaust pipe. D) wire runs hanging loose / not-supported..
